LONG-TERM EFFECTS OF DREDGING
OPERATIONS PROGRAM

TECHNICAL REPORT D-86-2

THE DUWAMISH WATERWAY CAPPING
DEMONSTRATION PROJECT: ENGINEERING
ANALYSIS AND RESULTS OF
PHYSICAL MONITORING

Clifford L. Truitt

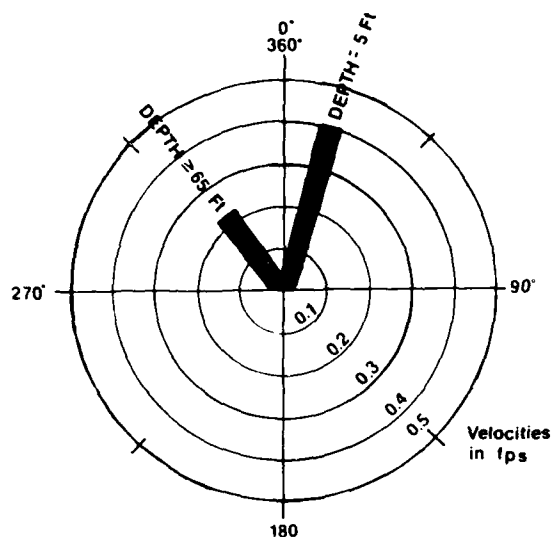
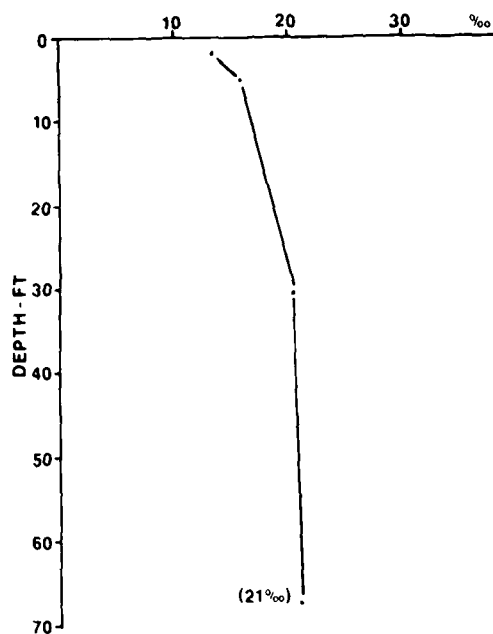
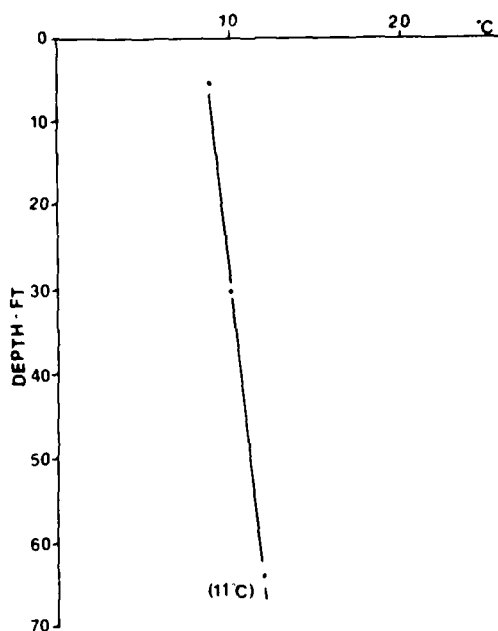
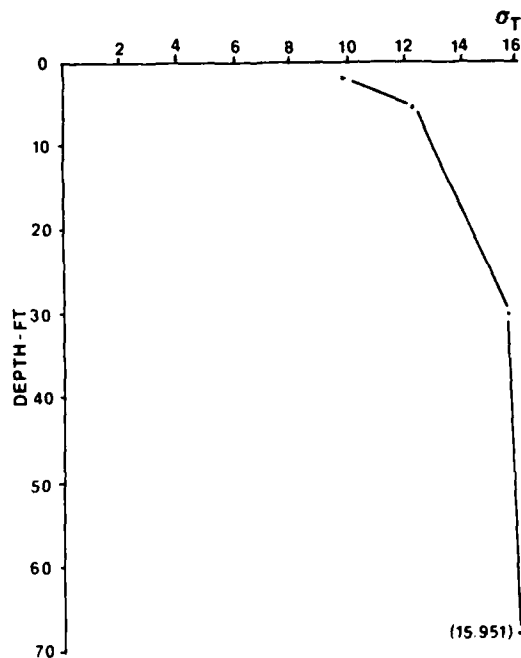
Figure 4. Physical parameters measured at disposal site

CURRENT SPEED AND DIRECTION

NOTE: Channel axis runs approximately north-south, 0°/360° is north.

SALINITY

TEMPERATURE

DENSITY

10. The highest current velocity measured during the fieldwork was a single value of 1.4 fps just beneath the water surface. Sustained maximum values in the upper third of the water column were more typically 0.4 to 0.8 fps. Sustained maximum values near the bottom were approximately 0.2 fps. The recording current meters showed frequent periods during which current velocities were less than the instrument threshold value of approximately 0.05 fps. Figure 4 presents a current rose representative of site conditions at the actual time of the disposal.

11. Ambient salinity, temperature, and density data are also presented on Figure 4. Bulk samples of the water at both the dredge site and the disposal site were obtained two days prior to the start of dredging for analysis of background chemical constituents and for use in elutriate tests. Results of these chemical analyses are shown in Table 1 as background values.

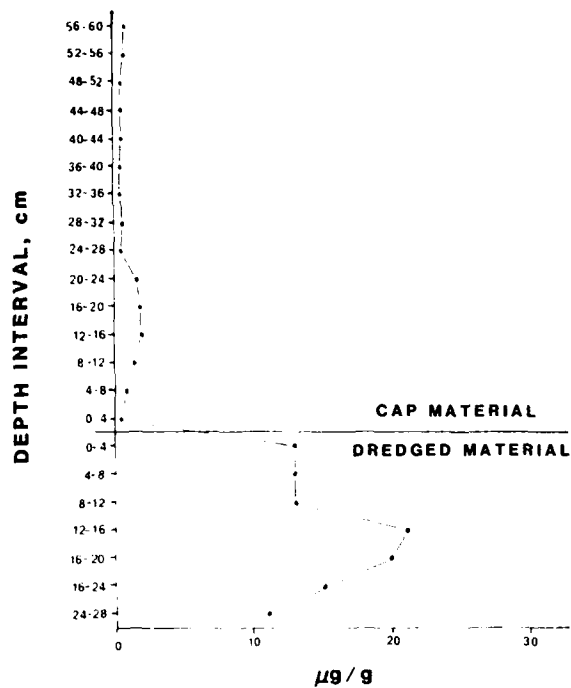
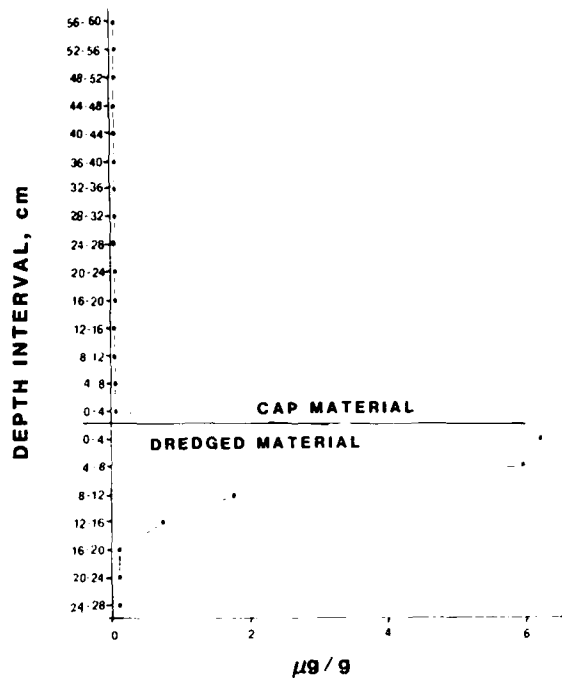
Figure 19. Chemical profile through the cap

LEAD

AROCHLOR 1242

82. Results of chemical analysis of initial core samples indicated that the dredged and cap materials formed a sharp, relatively unmixed interface. This is illustrated in Figure 19, which presents Pb and Arochlor 1242 PCB concentrations in a core at the Duwamish capping site. Both Pb and PCBs were initially either absent or present in low concentrations in the cap materials. Below the cap/dredged material interface, however, high concentrations of Pb and PCB relative to those in the cap material were noted.

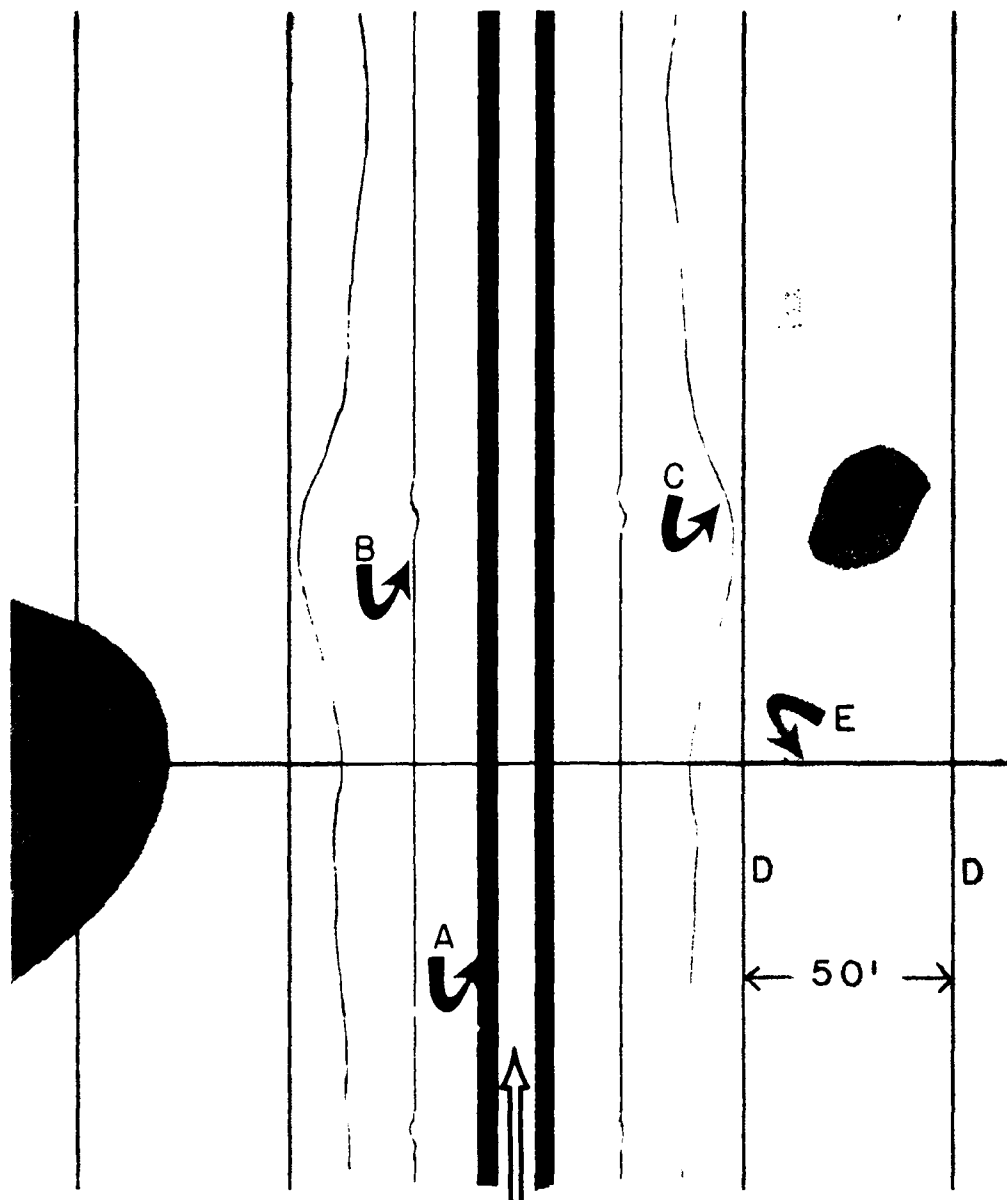
Figure B1. Example SSS record

DIRECTION OF FISH MOVEMENT

6. The following discussion applies to Figure B1. The dark parallel lines (A) running down the center of the sonograph are the starting points of
